Midpeninsula Regional
Open Space District

R-24-46
Meeting 24-09
April 10, 2024

Status Report and Disposition Direction for Unoccupied Structures

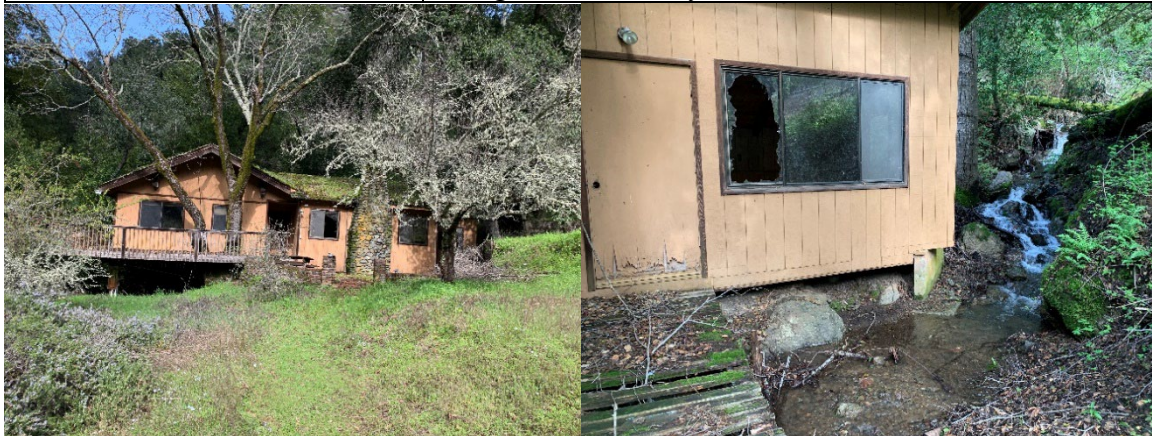
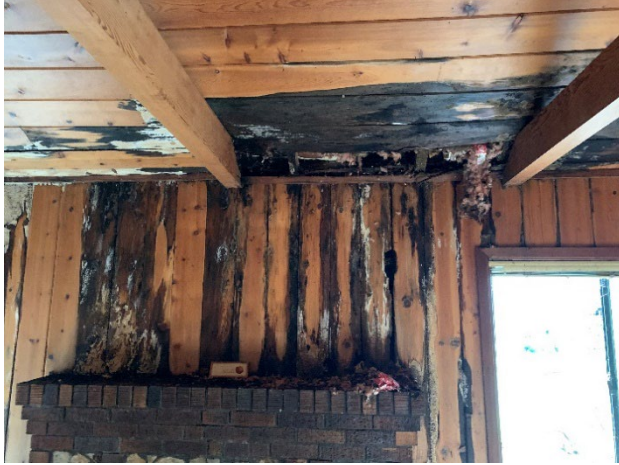
McKannay House

L. Condition of the Structure	Poor, extremely deteriorated, extensive water and rodent damage, built directly over a stream.

The General Manager recommends that this dilapidated abandoned residential site, consisting of a house, a shop building and a garage be demolished due to the infeasibility of reusing the structures and the inaccessibility of the site.

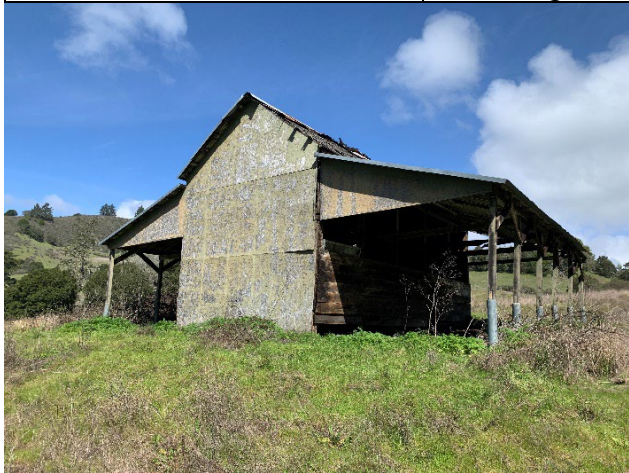
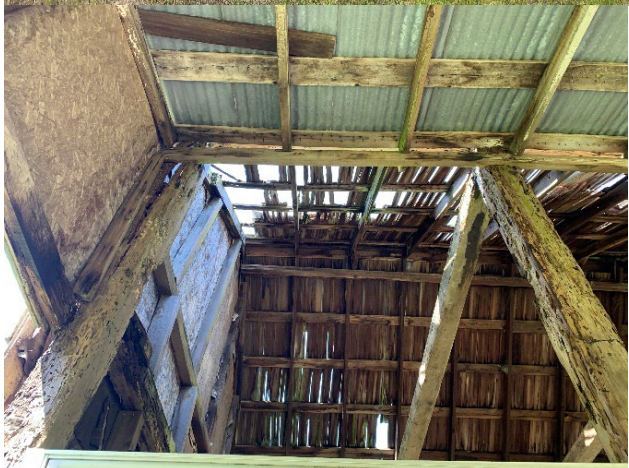
Apple Orchard Barn

E. Potential Financial Cost, Including Liability and Management	Use as a barn is limited since vehicle access would require a new vehicle bridge or major improvements on unmaintained access road from Sears Ranch Road for seasonal access. Barn itself would require major repairs and a new foundation. Wings would either need to be removed or entirely rebuilt.

G. Public Sentiment and Input	None
H. Regional Importance or Value	None
I. Strategic Fit	Removal is aligned with strategic goals to restore natural resources and reduce fire danger.
J. Tradeoffs and Impacts on District Resources	Would require major investment to make usable to construct new vehicle bridge over creek which would also have impacts that would need to be mitigated.
K. Visitor Experience	Currently no public access, if opened in the future, removal of delapidated barn would improve setting.
L. Condition of the Structure	Poor, wings in danger of collapse, main part of barn better but still poor, structurally would need new foundation, new roof and new siding.

The General Manager recommends that this dilapidated abandoned barn be demolished due to the infeasibility of reusing the structure and because there is no vehicle access to the site.

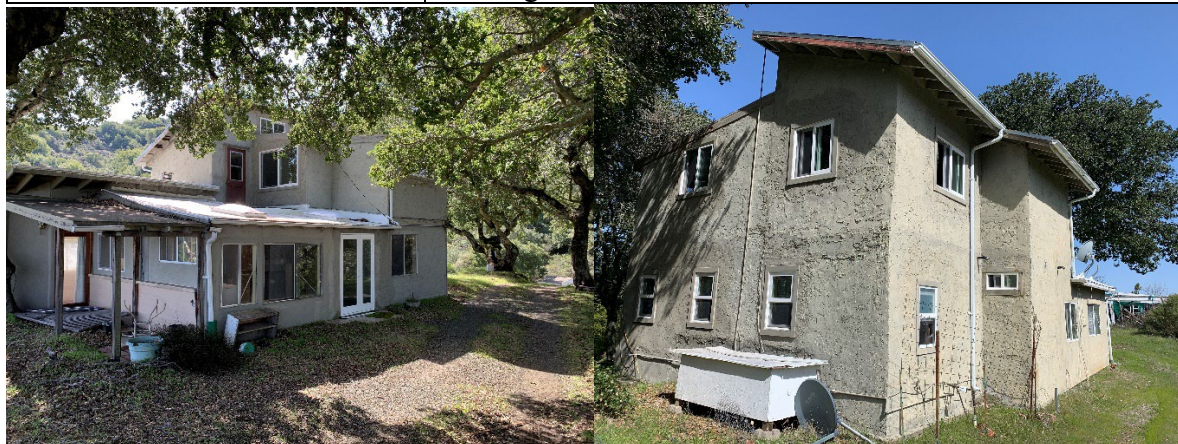
Meyer House

L. Condition of the Structure	Poor: structures are in poor condition and would require major upgrades to meet permit conditions, no viable water source was located onsite to meet permit conditions, power system unsalvageable.

The General Manager recommends that this dilapidated abandoned residential site consisting of a 2-story house, a garage/apartment and a storage shed be demolished due to the infeasibility of reusing the structures.

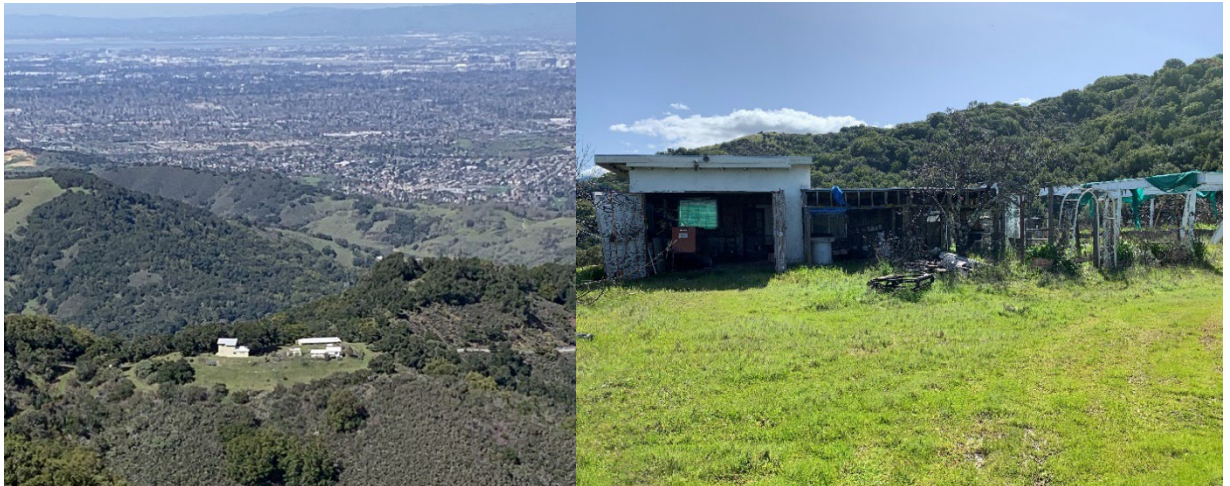
Meyer Garage/Apartment

View from Bald Mountain

Garage and Debris

Both the main house and the apartment garage were evaluated for reuse as a ranger residence. The project to provide a ranger residence by repairing Meyer was changed to the residence on Pheasant Road due to the cost of developing a reliable water system, poor condition of the house, the need to create a new power supply, and permitting issues.

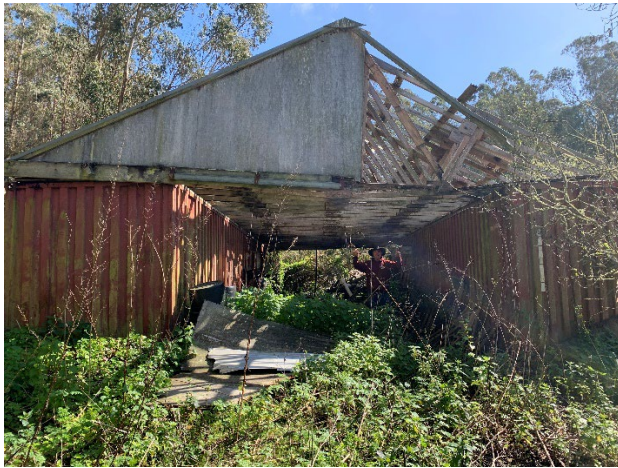
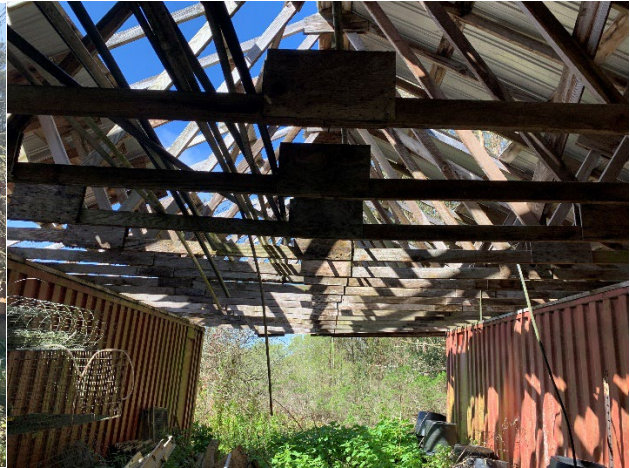
Toto Hay Barn

At the time of purchase, the barn was already in poor condition. It is a simple construction of two shipping containers supporting a wooden roof. Currently the storage containers have rusted through, and the roof is unsalvageable, and the shipping containers are not reuseable.

L. Condition of the Structure	Poor.
-------------------------------	-------

The General Manager recommends that this dilapidated barn that is based on a foundation of two shipping containers be demolished due to the infeasibility of reusing the structure.

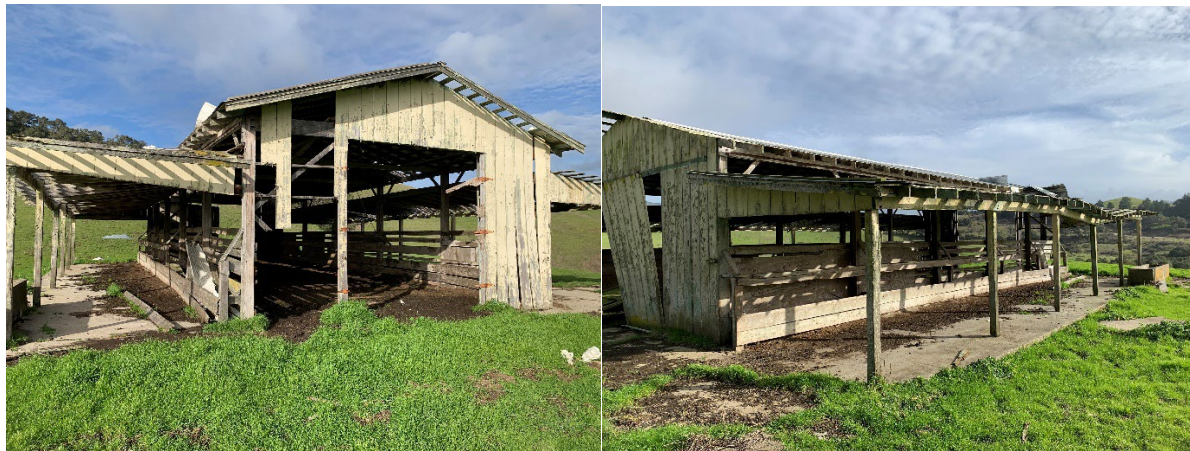
Sears Ranch Road Open Air Barn

E. Potential Financial Cost, Including Liability and Management	Reuse and rehabilitation would require new foundation, new roof new siding and replacement of rotted structural timber.

L. Condition of the Structure	Poor: roofing pieces are lying around the site, one wing is collapsing, and it is in danger of full collapse.

The General Manager recommends that this dilapidated abandoned barn be demolished due to the infeasibility of reusing the structure and to prioritize repairs to the barn that is actively used by the current grazing tenant.

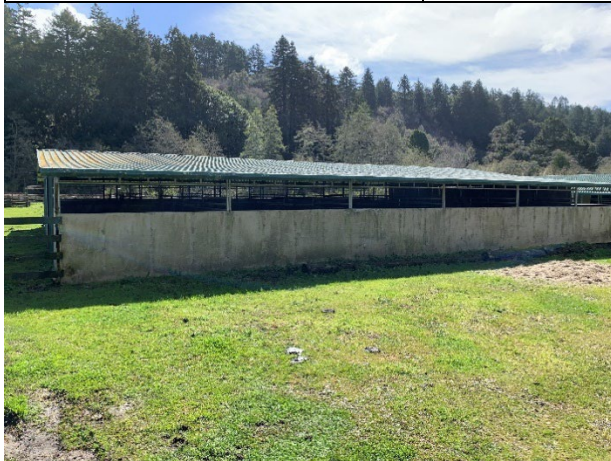
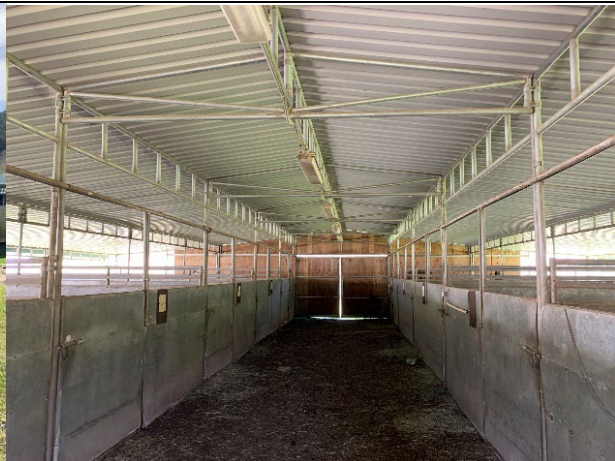
Event Center –Cow Barn

L. Condition of the Structure	Good to fair and reusable at a different site.

The General Manager recommends that this modular construction barn be removed from the Event Center to meet permitting conditions and the components be reused elsewhere if feasible.

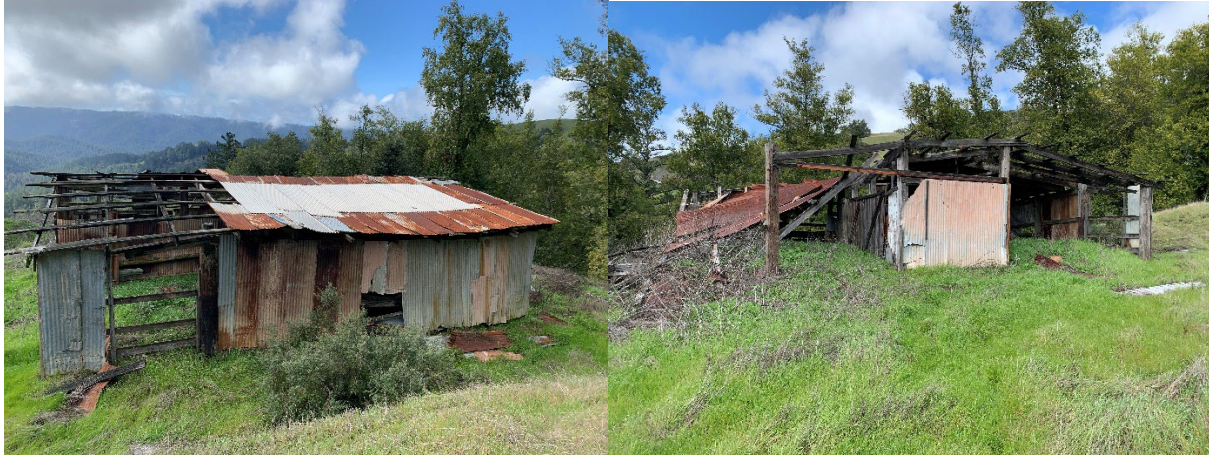
Big Dipper Barn

J. Tradeoffs and Impacts on District Resources	Replacement would provide no benefit.
K. Visitor Experience	No public access at this time, not visible from open areas of the preserve or public roadways.
L. Condition of the Structure	Partially collapsed

The General Manager recommends an expedited disposition decision-making process, pending the results of an historic evaluation of this dilapidated abandoned barn. This barn is not being used. There is another barn on the property adjacent to the District employee residence that is actively used. An additional barn on the property, the former Monotti Barn, is listed for retain in current state in this report.

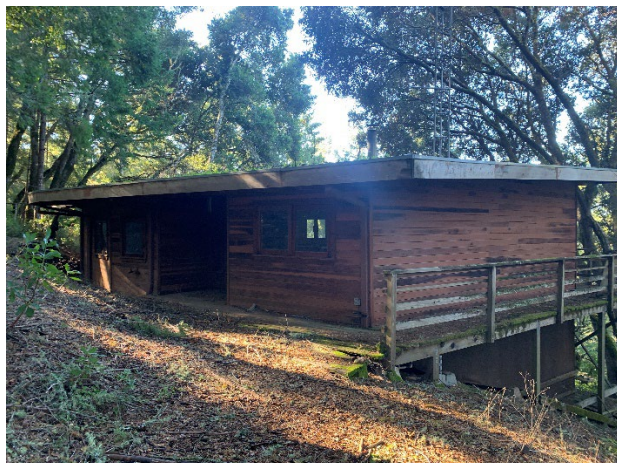
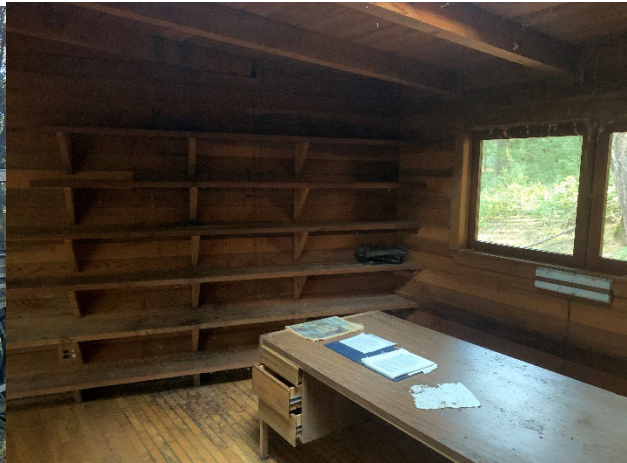
Landre House

L. Condition of the Structure	Poor, power and water would have to be reestablished. Off the grid property. Entire deck would need to be removed and rebuilt, stairs accessing structures have collapsed, extensive rodent and water damage would require complete gutting and structural repairs.

The General Manager recommends an expedited disposition decision-making process, pending the results of an historic evaluation of this dilapidated abandoned residential site, consisting of a main house, a secondary apartment and a cabin be demolished due to the infeasibility of reusing the structures and the inaccessibility of the site.

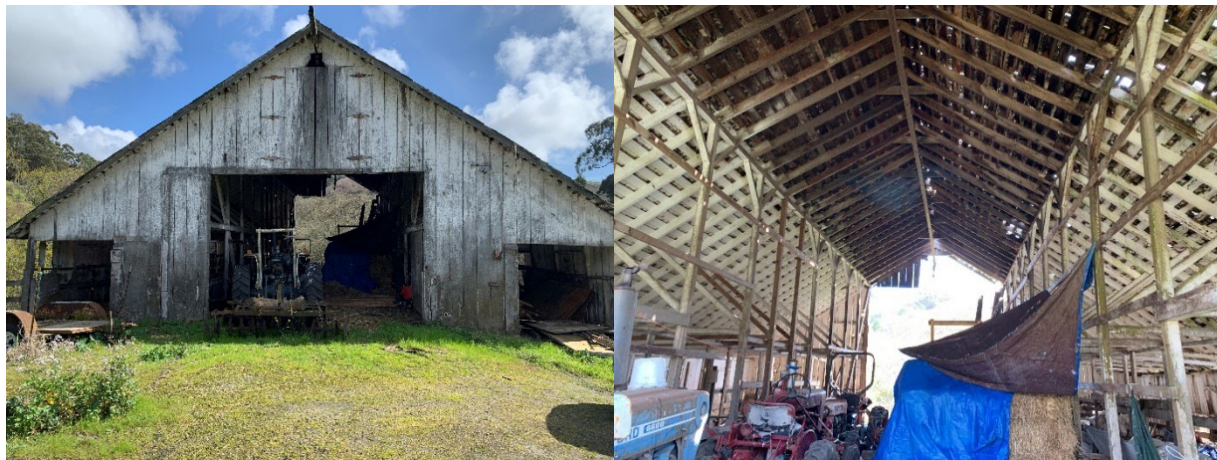
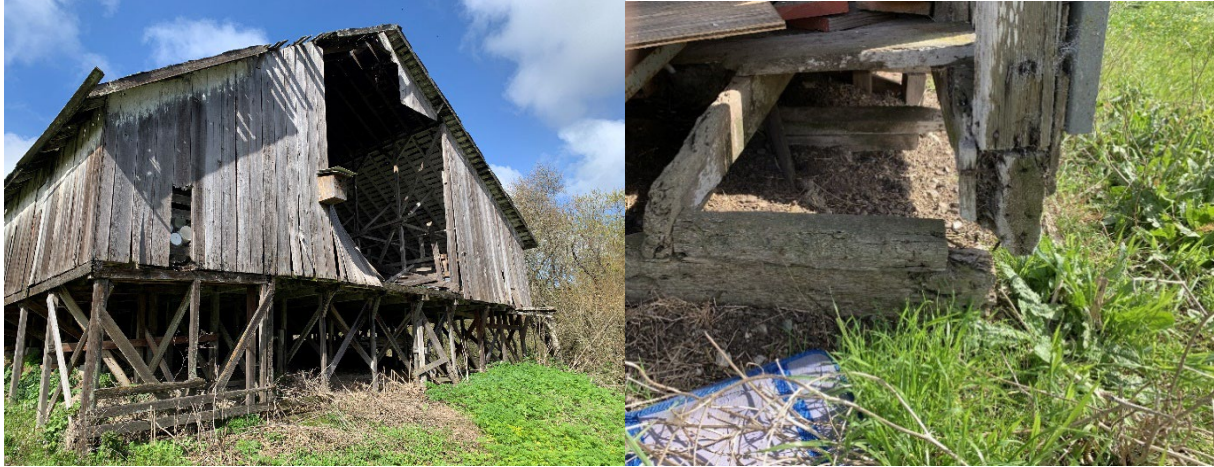
Lobitos Agriculture Barn (front)

K. Visitor Experience	No visitor access at this time. It is part of the rural agricultural scene while driving along Purisima Creek Road
L. Condition of the Structure	Poor but appears currently stable.

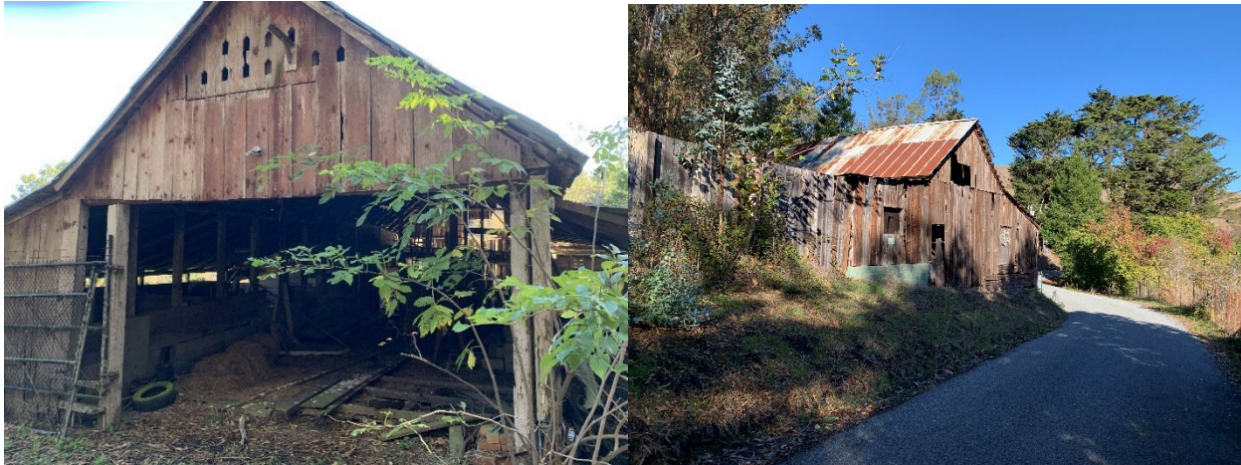
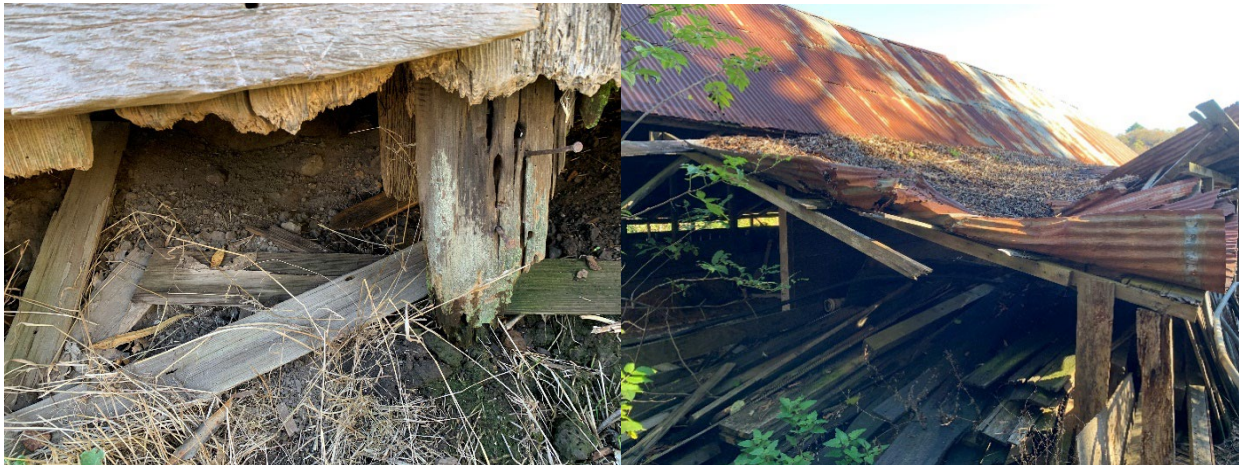
October Farms Barn

The barn is in extremely poor condition and is in danger of collapse. It is not currently used.

K. Visitor Experience	No current public access, visitor wouldn't typical use Lobitos Creek Road to access preserves
L. Condition of the Structure	Poor condition, in danger of collapse.

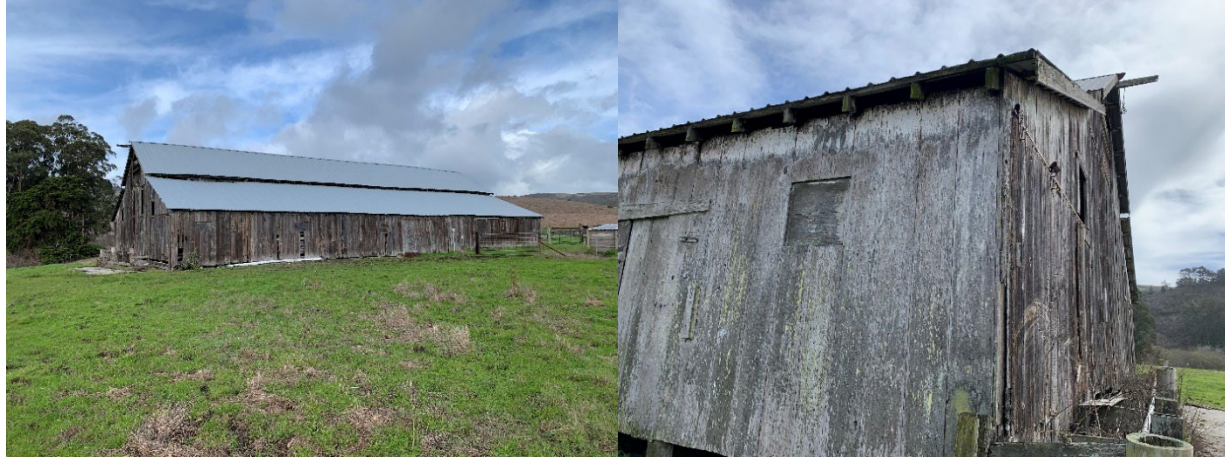
Gordon Ridge Barn

K. Visitor Experience	Currently no public access but visible from visitors travelling on Hwy 84
L. Condition of the Structure	Fair.

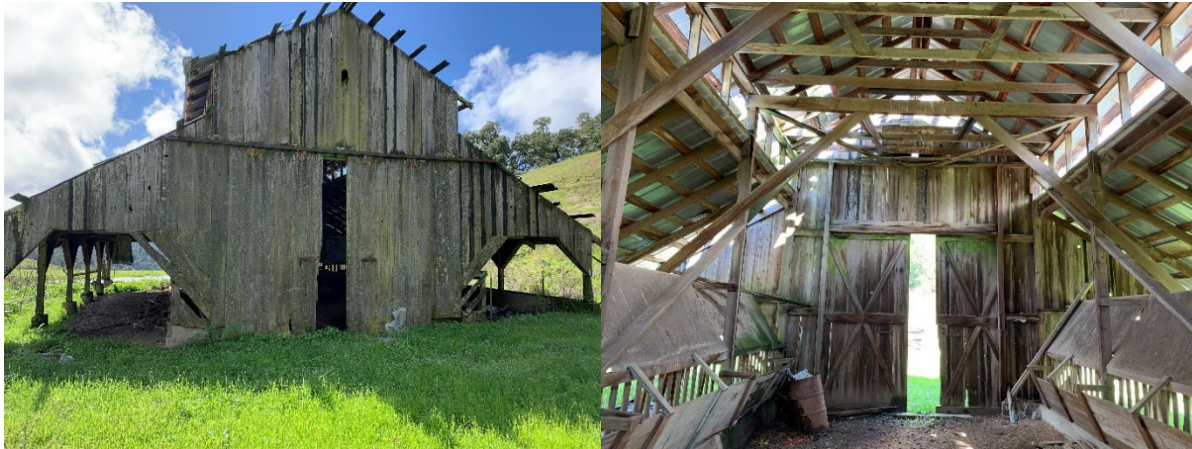
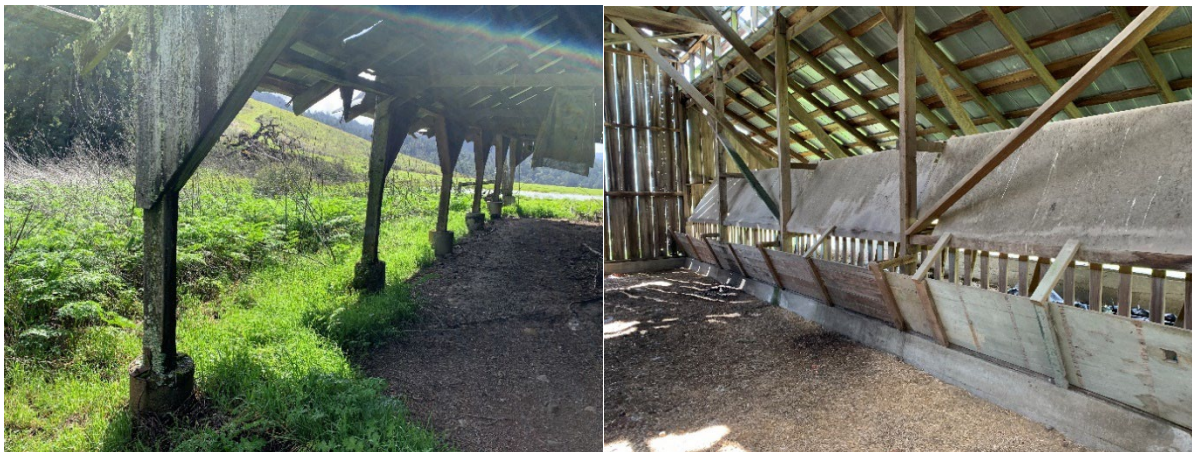
Big Dipper Ranch Barn (AKA Monotti Ranch Barn)

I. Strategic Fit	Primary value as scenic backdrop and potential use by grazing tenant.
J. Tradeoffs and Impacts on District Resources	May be expensive to repair/rehabilitate
K. Visitor Experience	Currently no public access. If access is added in the future barn adds to rural character and fits in with the surrounding grasslands.
L. Condition of the Structure	Fair to poor.

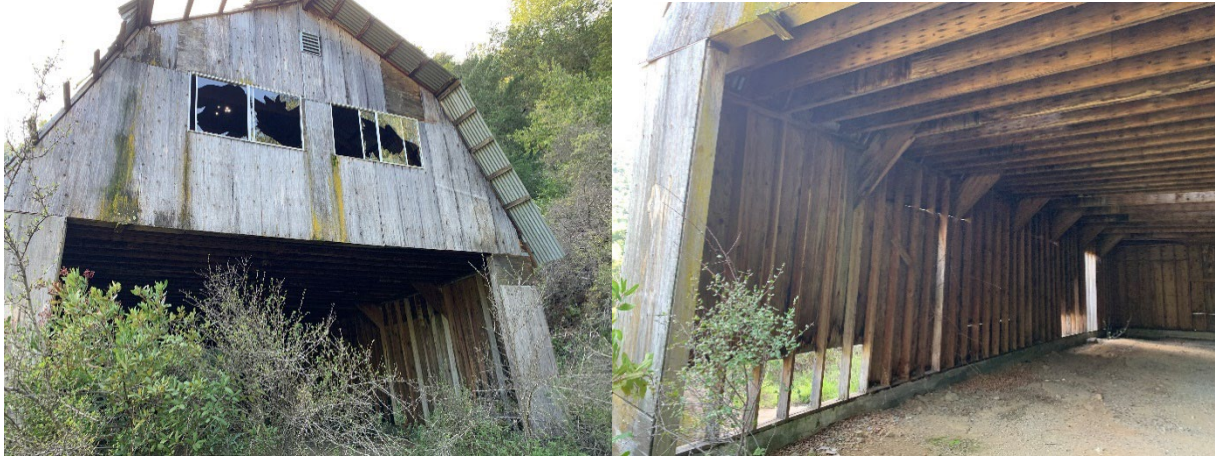
Alsberge Barn

K. Visitor Experience	None
L. Condition of the Structure	Poor overall, with solid poured foundation but some structural wood starting to rot.
